SHORE EROSION STUDY

SHORELINE EROSION AND BLUFF STABILITY ALONG LAKE MICHIGAN

AND LAKE SUPERIOR SHORELINES OF WISCONSIN

OZAUKEE COUNTY

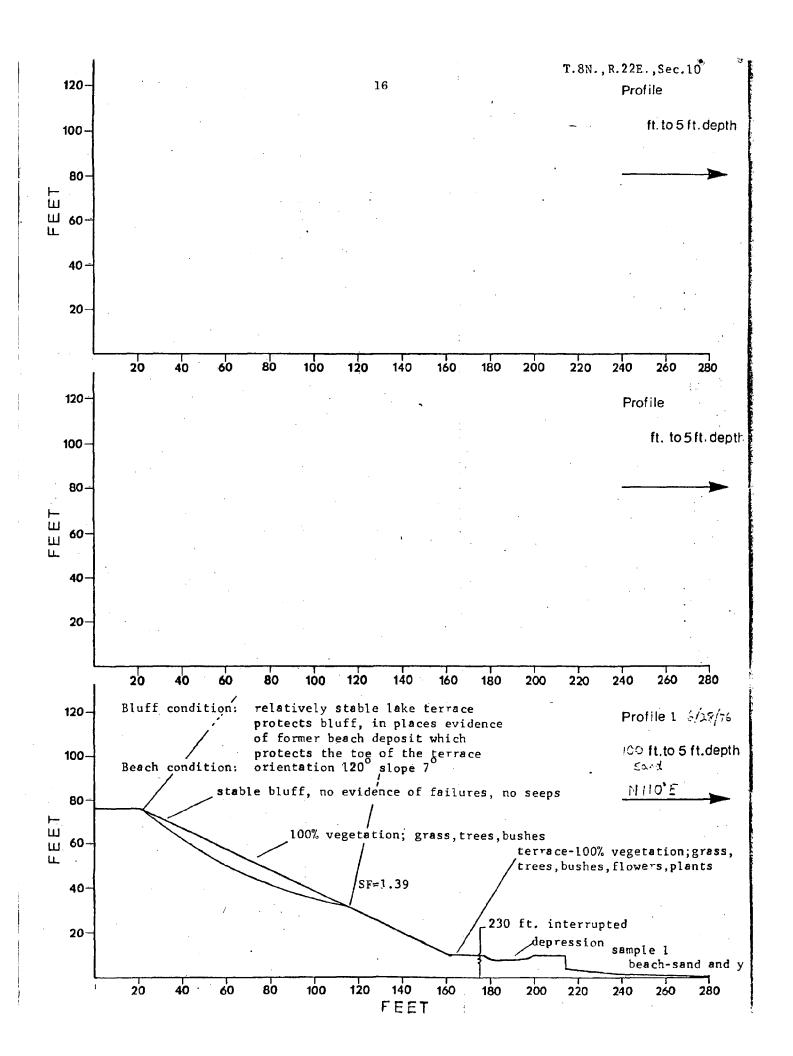
1. BLUFF	a-former lake terrace protects a bluff with approximately a 25° slope with 100% vegetation. No evidence of failure on the bluff.	b-No lake terrace, 100% vegetation on a stable bluff, 30° slope. Seawall to protect toe. no evidence of bluff failure.	c-Former lake terrace protects a bluff with approximately a 25 slope with 100% vegetation. No evidence of failure on the bluff.
2. TOE	a-toe material not visible due to shore structeres and vegeta- tion	b-sand	
3. BEACH	a30 ft. in the south grading to no beach in the north, composed of medium grained sand	b-no beach	c15 ft. medium grained sand
	d- +25 ft. medium grained sand

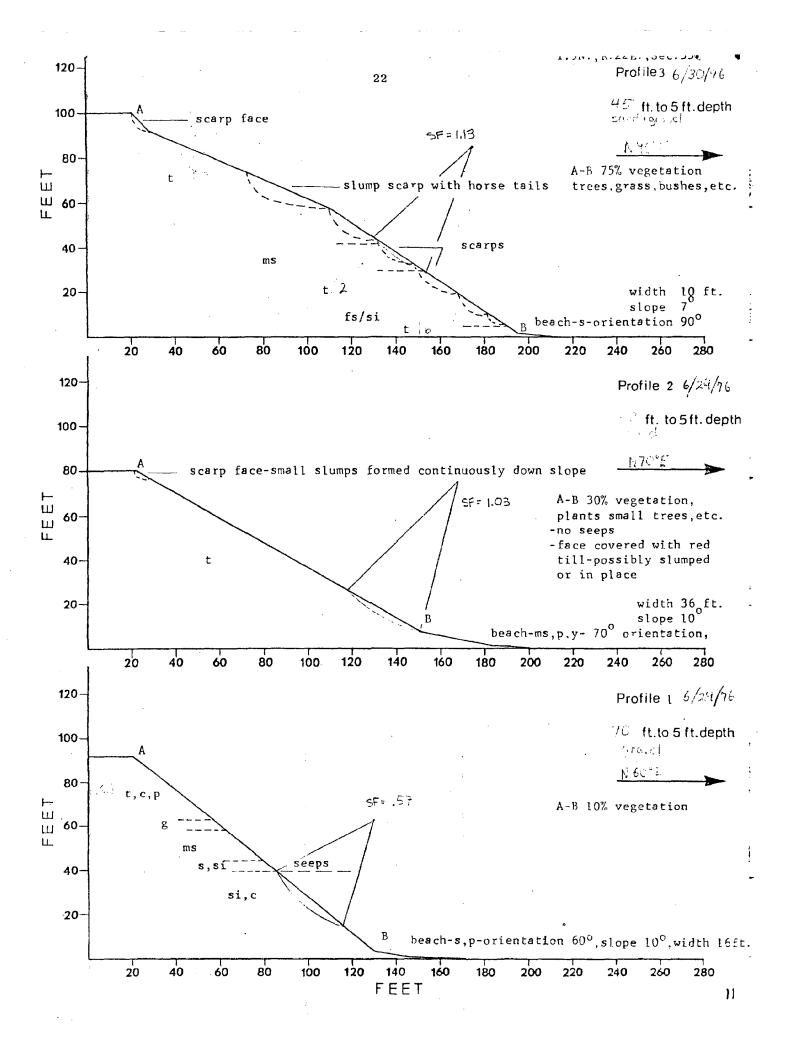
l. BLUFF	a-bluff slope approximately 40° at top with a scarp face, 30° continuously down slope from bottom of scarp. Bluff seems to be a series of minor translational faults that are sliding downslope as the toe material becomes eroded by wave action. Vegetation ranges between 10% and 90% Scarp at top of bluff continous through the section regardless of vegetation.				
2. TOE	a-slumped till and vegetation continuously through the entire section.				
3. BEACH	a-15-25 ft. beach-medium b25 ft. beach-grained sand from bluff medium grained sand medium sand, no pebbles or cobbles. ft. from water's edge. spproximately 10-15 ft. from water's edge where cobbles at water's edge. pebbles and cobbles continue to water.

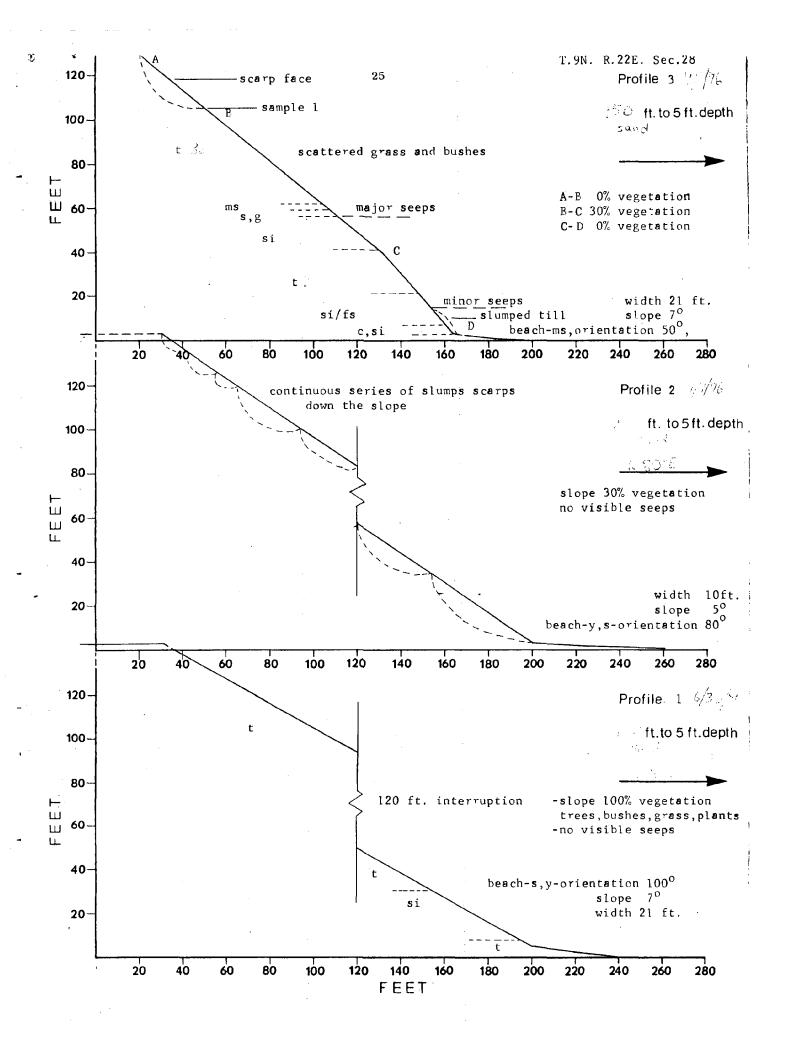
-				
1. BLUFF	a-scarp face at the top of the bluff, translational movement (sliding, flowage and small slump blocks) all the way down the bluff face.	b-scarp face at the top of the bluff small slumps continuously down the upper ½ of the bluff along with translational movement. The lower ½ consists of flowage, slump blocks and translational movement. The toe is being eroded by wave action		
2. TOE	a-slumped till covering in place silt and sand, in some places till.			
3. BEACH	a-15-25 ft.beach- pebbles and cobbles grading into medium grained sand at the toe of the bluff.

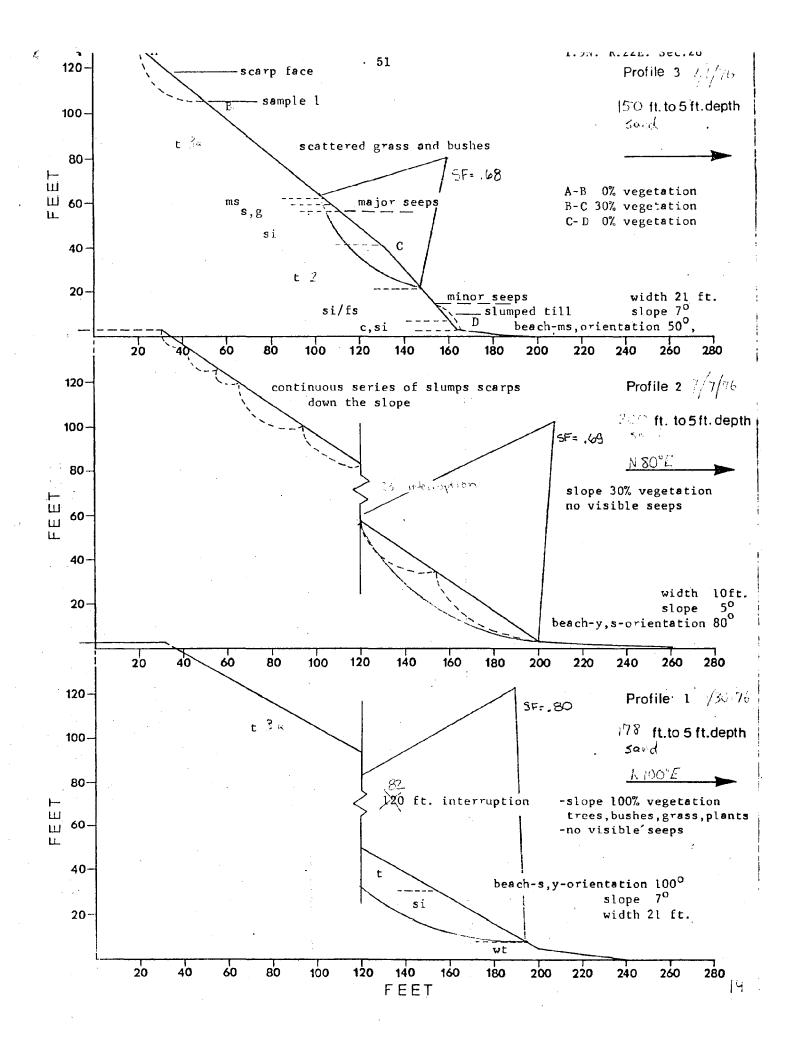
1. BLUFF	a-scarp face at the top of the bluff, translational movement (sliding, flowage and small slump blocks) all the way down the bluff face.	b-scarp face at the top of the bluff, small slumps continuously down the upper ½ of the bluff along with translational movement. The lower ½ consists of flowage, slump blocks and translational movement. The toe is being eroded by wave action.
2, TOE	a-slumped till covering in place silt	and sand, in some places till.
3. BEACH	a-15-25 ft.beach- pebbles and cobbles the toe of the bluff.	grading into medium grained sand at

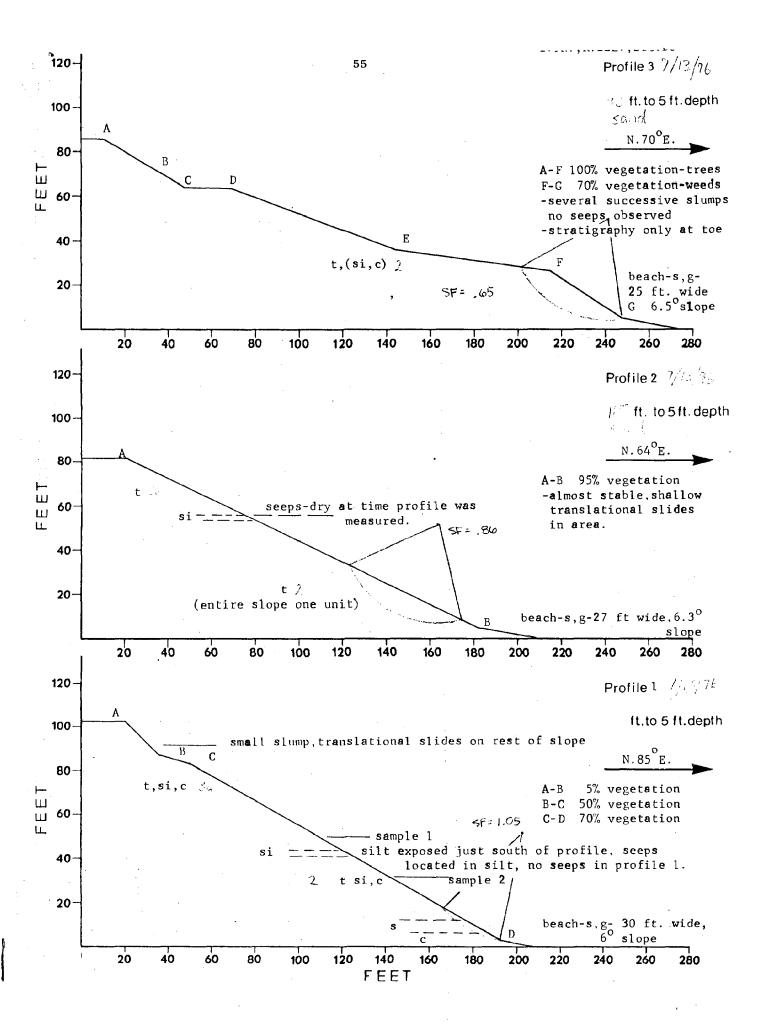
1. BLUFF	a-translational slides, toe erosion	b-translational slides on lower 3/4 of slope, rota- tion slump on upper 1/4 of slope	c-relatively stable, no recent failures	d-almost stable, several large slump blocks (slump blocks old, no recent slumping)
2. TOE	a-slide debris, red brown till and silt	b-in place silt, often with red brown till veneer 3 ft. above beach	c-in place gray clayey till	d-in place red brown till
3. ВЕАСН	a- +20 ft. sand with gravel at high wave mark e- +20 ft. sand with gravel at high wave mark	b-5 to 20 ft. sand with gravel at high wave mark	c~ +20 ft. sand with gravel at high wave mark	d5 ft. gravel

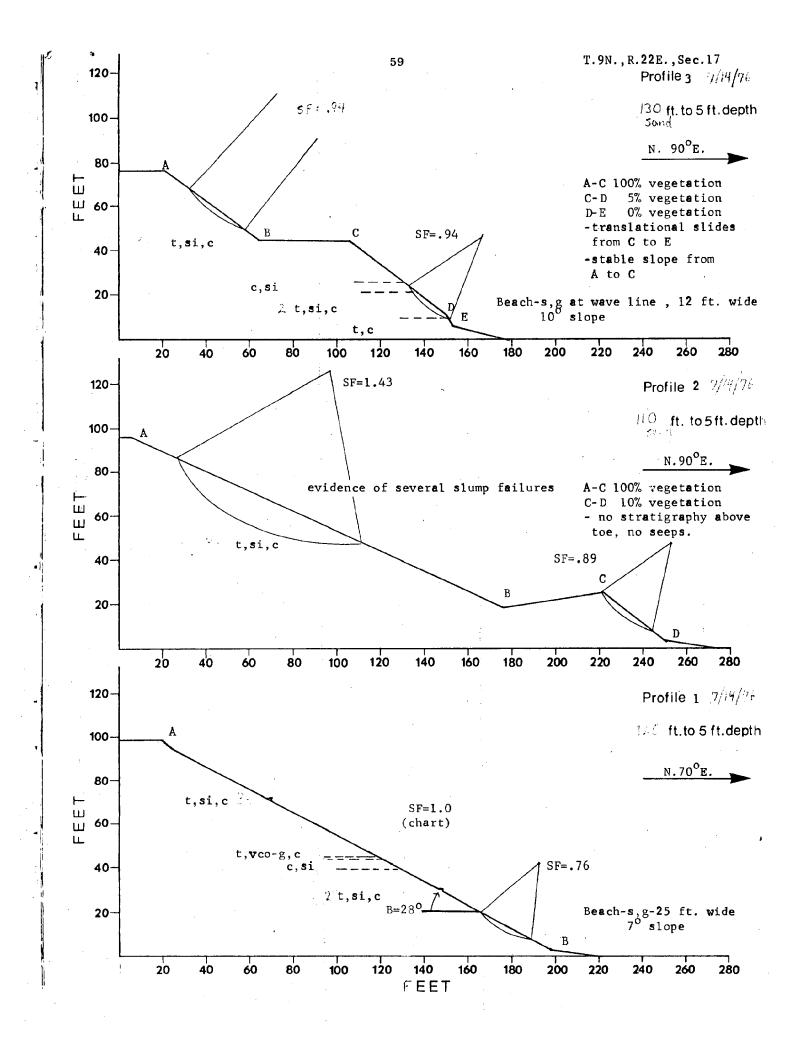
1. BLUFF	a-large deep seated slump failures, old slumps, no recent failures e-two large steps make up the slope, one old and very large slump block forms lower ½ of bluff, trans- lational slide on this block surface	·	c-large deep seated slumps	d-translational slides
2. TOE	a-toe material red-brown till		ection is slumped	l and in place
3. BEACH	a20 ft. upper ½ of beach is sand, lower ½ is gravel	b-5-20 ft. upper ½ is sand, lower ½ is gravel	c20 ft. upper ½ is sand, lower ½ is gravel	d-5-20 ft. upper ½ is sand, lower ½ is gravel

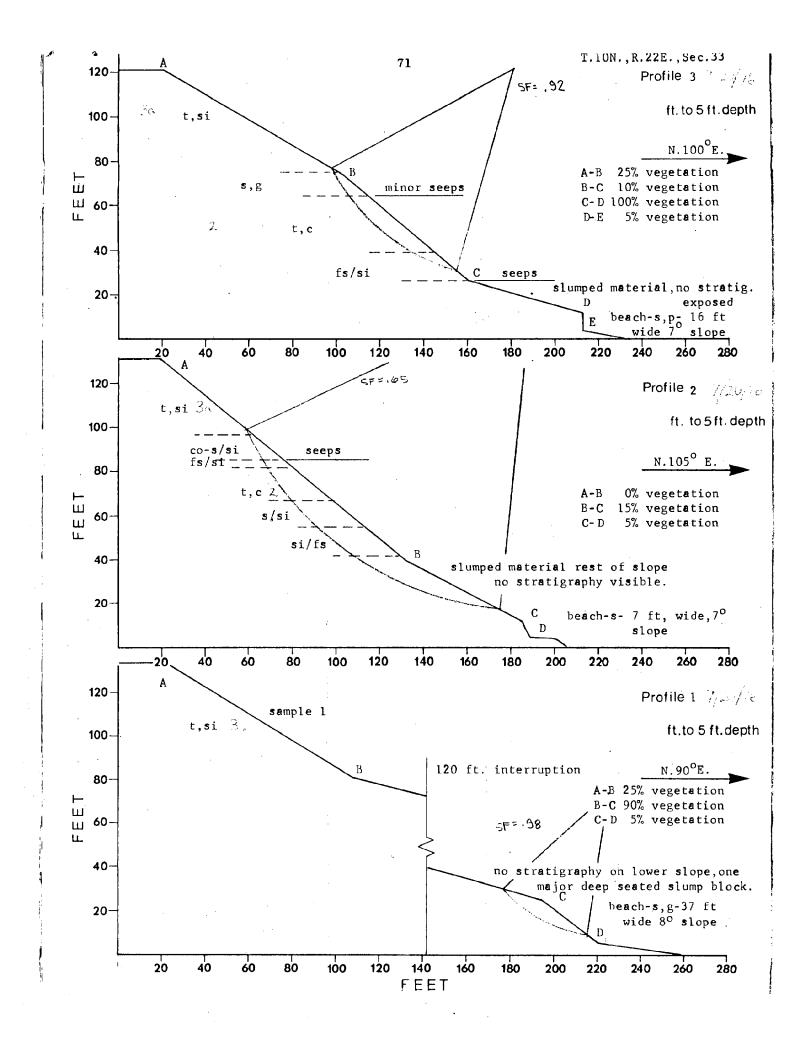
1. BLUFF	a-major deep seated slumping	b-shallow slumps and many slides.	c-major deep seated slumping	d-shallow slumping, many slides
2. TOE	a-slumped till	b-slumped till, silt and sand	c-slumped till	
3. BEACH	a- +20 ft. upper 2/3 sand, lower 2/3 pebbles and cobbles	b-5 to 20 ft. sand and gravel	c- +20 ft. sand on upper ½, gravel on lower ½	d-5 to 20 ft. sand and gravel

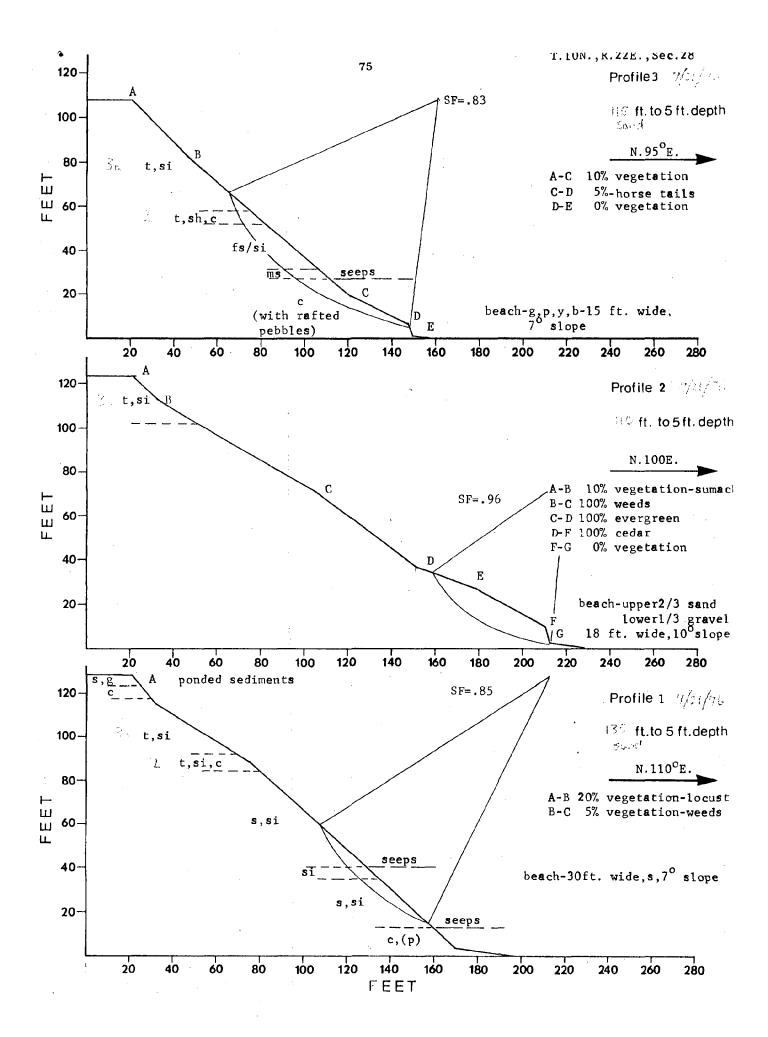
1. BLUFF	a-translational slide, rapid toe erosion f-old slumping	b-major deep seated slump blocks (old)		d-slumping (recent) shallow	e-translational slides
2. TOE	a-in place lacustrine silt and clay	b-slumped till and silt and sand	c-in place silt and clay (lacustrine)	d-slumped till and silt	
3. BEACH	a5 ft. gravel and broken trees	b- +20 ft. sand with gravel at water line	c-5 to 20 ft. upper 1/3 sand ,1ower 2/3 gravel	d- + 20 ft. upper ½ sand,lower ½ gravel	e-5 to 2 0 ft. sa nd
	f5 ft. gravel	g-5 to 20 ft. sand

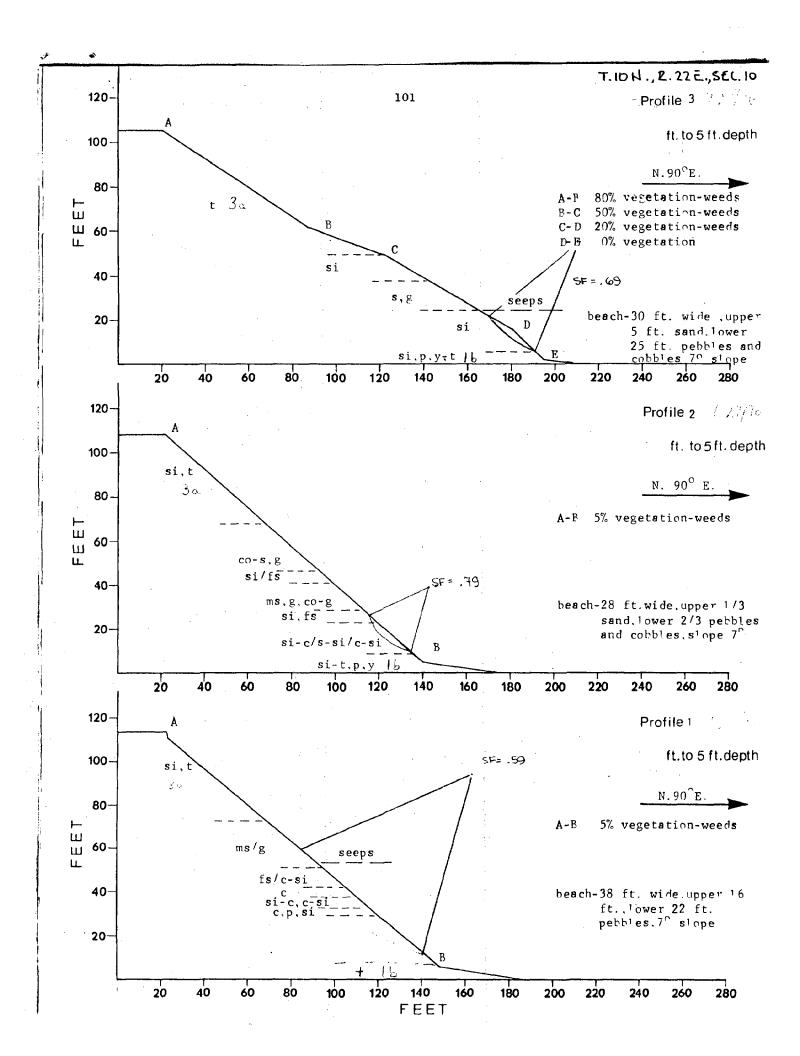
. Morr	slides due to rapid toe erosion		c-translational slope failures	
2. TO E	a-red brown till, slumped	b-in place silt and lacustrine clays	c-in place intermediate till	d-slumped red-brown till and in place intermediate till
3. ВЕАСН	a-greater than 20 ft. upper 1/2 sand, lower 1/2 pebbles		b-greater than sand cobb	20 ft., mix of oles.

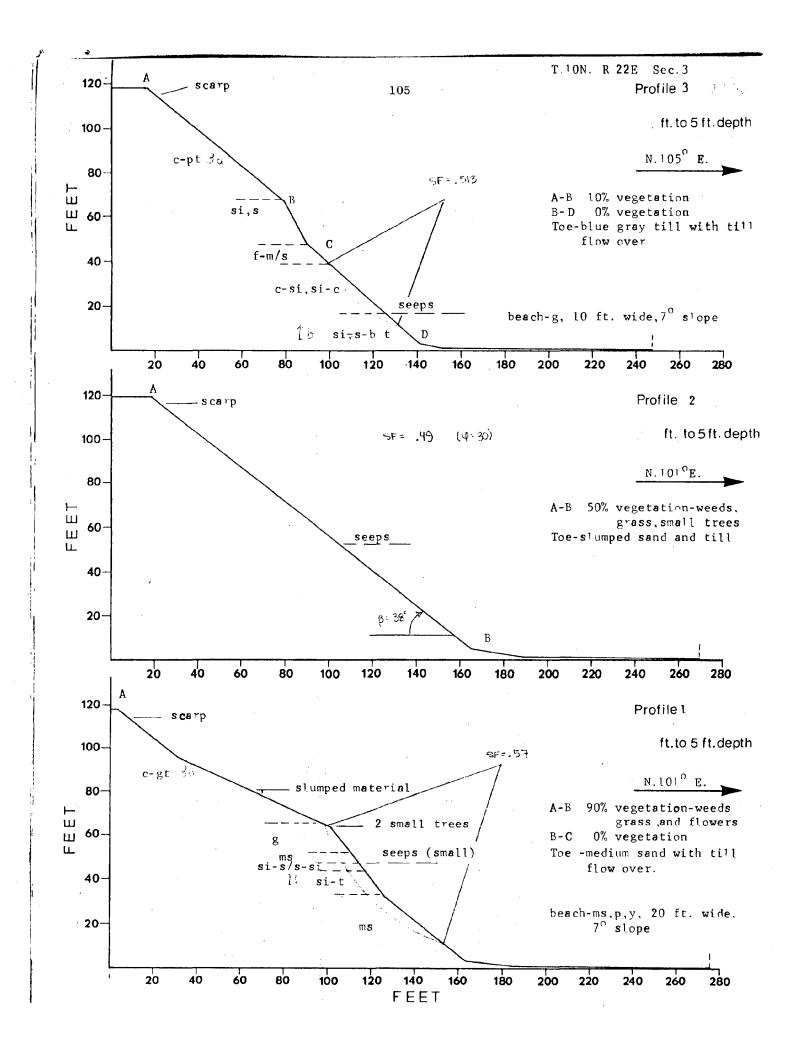
1. BLUFF	at the locations of the draina Vegetation is sparse throughou locations of the escarpments. translational movement of mate	t the section, except at the Bluff failure seems to be rial aided by groundwater sapping ghout the section. Severe wave
2. TOE	<pre>a-medium grained sand with flow till(red-brown) covering in places.</pre>	b-blue-gray till with red-brown flow till covering in places.
3. BEACH		, cobbles and gravel at the water's ed sand which continues to the toe

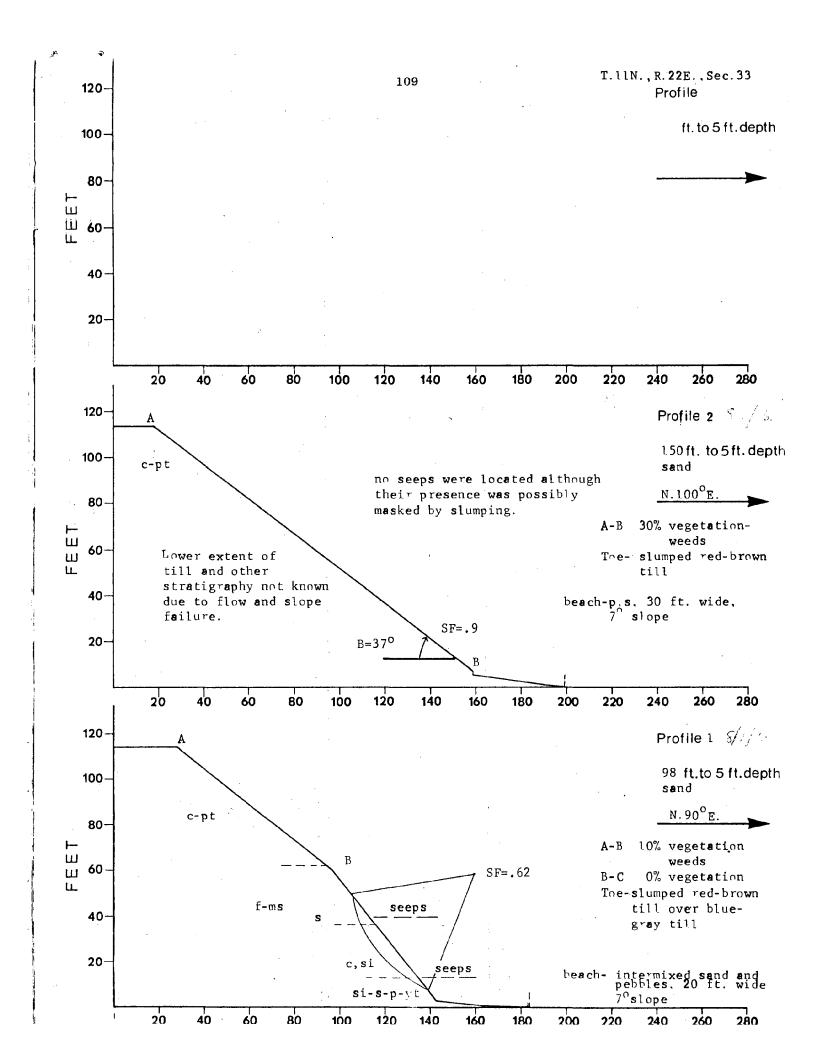
1. BLUFF	a-unstable bluff,7 drainage escarpments, translational failures of material, minimal vegetation, most areas no vegetation at all. 40° slope with excessive undercutting of toe material by wave action. Two major seeps continuously through the stretch, failure scarp at top of bluff.	b-unstable bluff, rotational slumping of material 40% vegetative cover for most of stretch. Slump scarps at top of the bluff continuously through stretch. Toe material is slumped red-brown till, excessive undermining of the toe by wave action.	
2. TO E	a-red-brown clayey till over blue-gray silty till or over stratified silty clay.		
3. ВЕАСН	a-beach width 20-30 ft. with intermixed pebbles and sand extending continuously from the water's edge to the toe of the bluff.

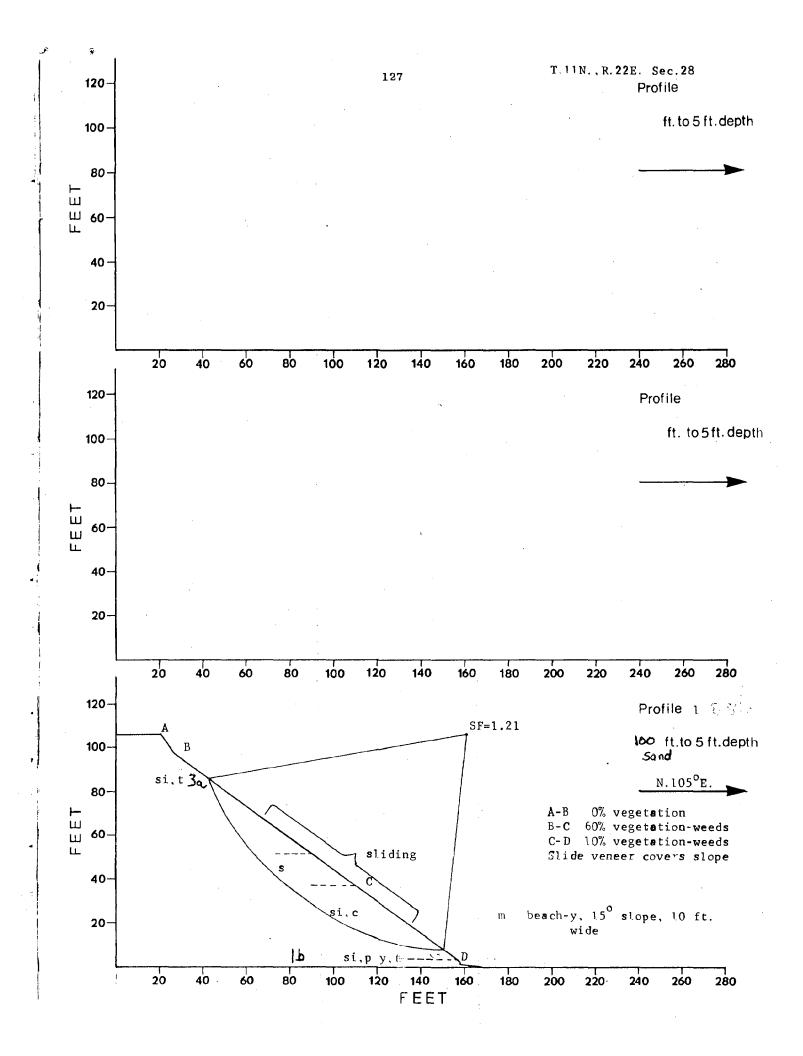
1. BLUFF	a-completely protected by jetty, sea- walls and revetment	b-very rapid erosion, very steep slumping planes and slides.	c-unstable, slumping and slides of a block torn from upper slopes	
2. TOE	a-slumped red-brown silty till	b-red-brown silty till slide debris and in place gray pebbly, cobbly till		
3. BEACH	a-no beach seawalls, jetty, revetment	b-sand, 15 ft. wide	c-revetment, (sewage treatment plant)	d-sand, 5 to 20 ft.
	e-cobbles 5 to 2 0 ft.	,	·

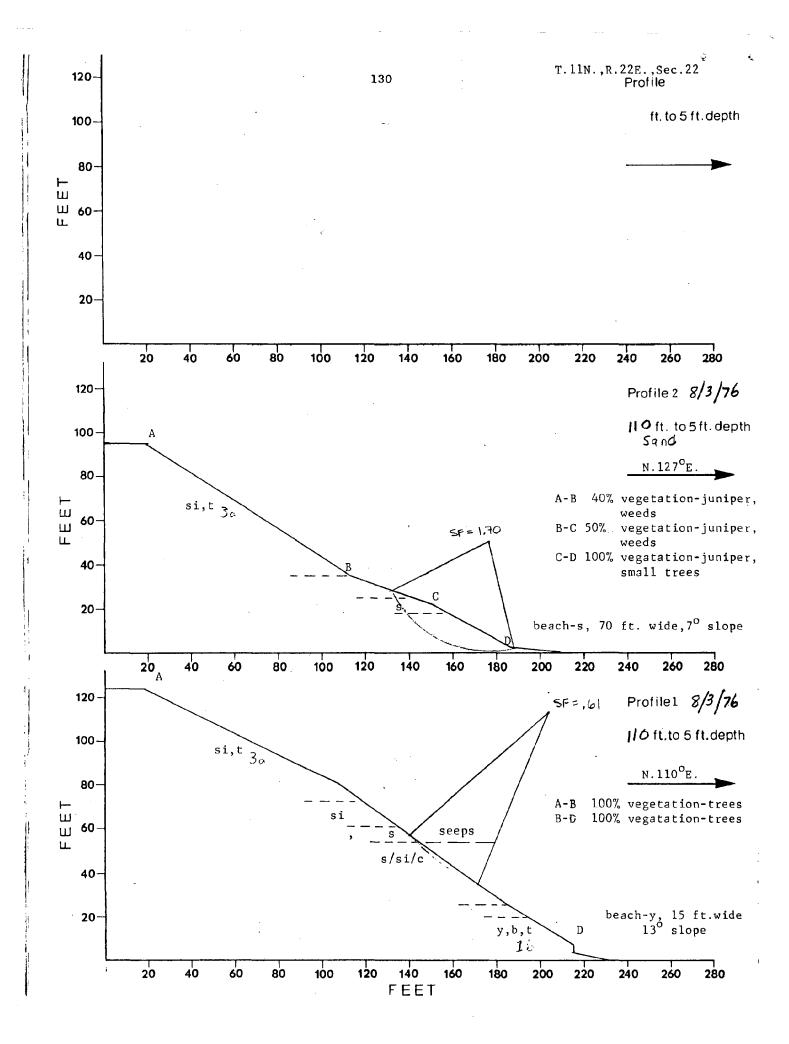
1. BLUFF				
1. BLUFF	a-shallow translational slides on lower slope slumping on upper slope	b-almost stable, subject to failure translational slides	c-several translational slides	d-relatively stable,no recent failures
	e-shallow translational slides	f-bluff almost stable, erosion caused by drainage system		
2. TOE	a-red-brown till slide debris	b-not visible	c-red-brown till slide debris	d-not visible, in places a sand terrace is found
	e-red-brown till slide debris	f-sand terrace over bluff toe		
3. BEACH	a-5 to 15 ft. cobbles	b-20 to 25 ft. sand	c-5 to 20 ft. sand and cobbles	d-very wide +30 ft. sand with gravel (pebbles) at water line
	e- +70 ft. sand with gravel (pebbles) at water line

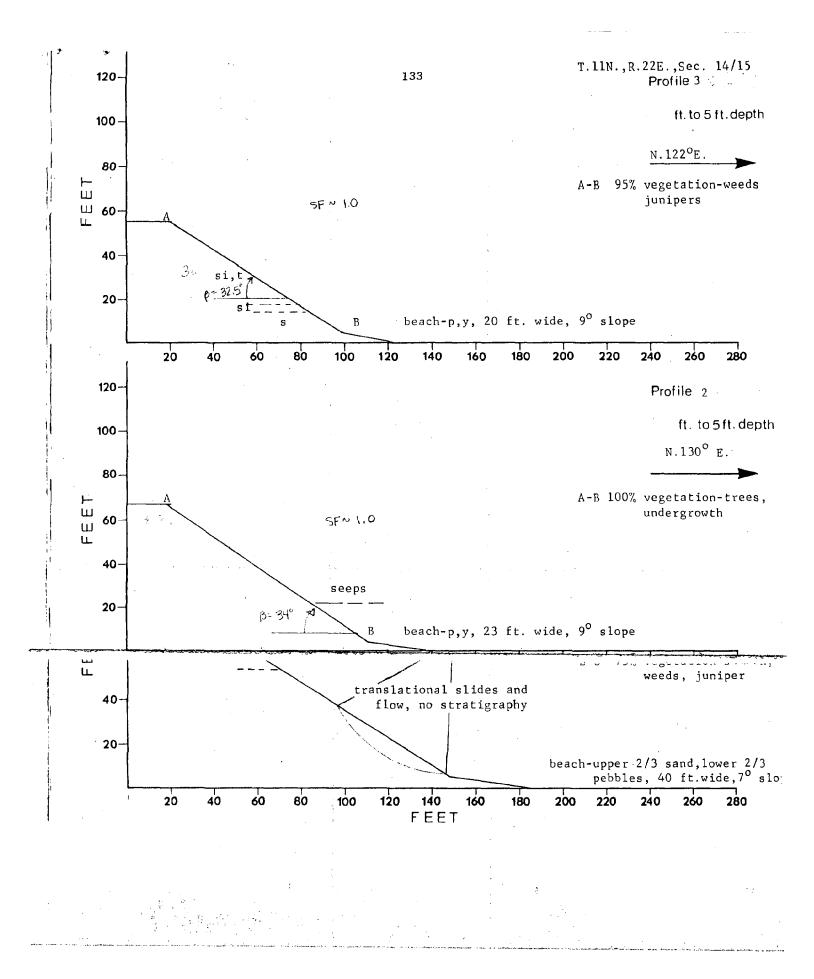
1. BLUFF	a-shallow translational slides	b-relatively stable, no recent failures. Steep slope and narrow beach make future stability doubtful.	c-shallow translational slides	d-small terrace
	e-no bluff or terrace, gentle rise	f-level sand terrace with gentle rise beyond	g-low bluff subject to translational slides	
2. TOE	a-red-brown till slide debris	b-not visible, most likely in place gray pebble, cobble till	c-red-brown till slide debris	d-sand terrace
	e-sandy silt in place	f-sand terrace	g-sand in place	
3. ВЕАСН	a-less than 20 ft. sand	b-25 ft. cobbles and pebbles	c-5 to 20 ft. cobbles and pebbles	d-5 to 15 ft. cobble and pebbles
	e-15 ft. sand	f-5 to 20 ft. cobbles and pebbles

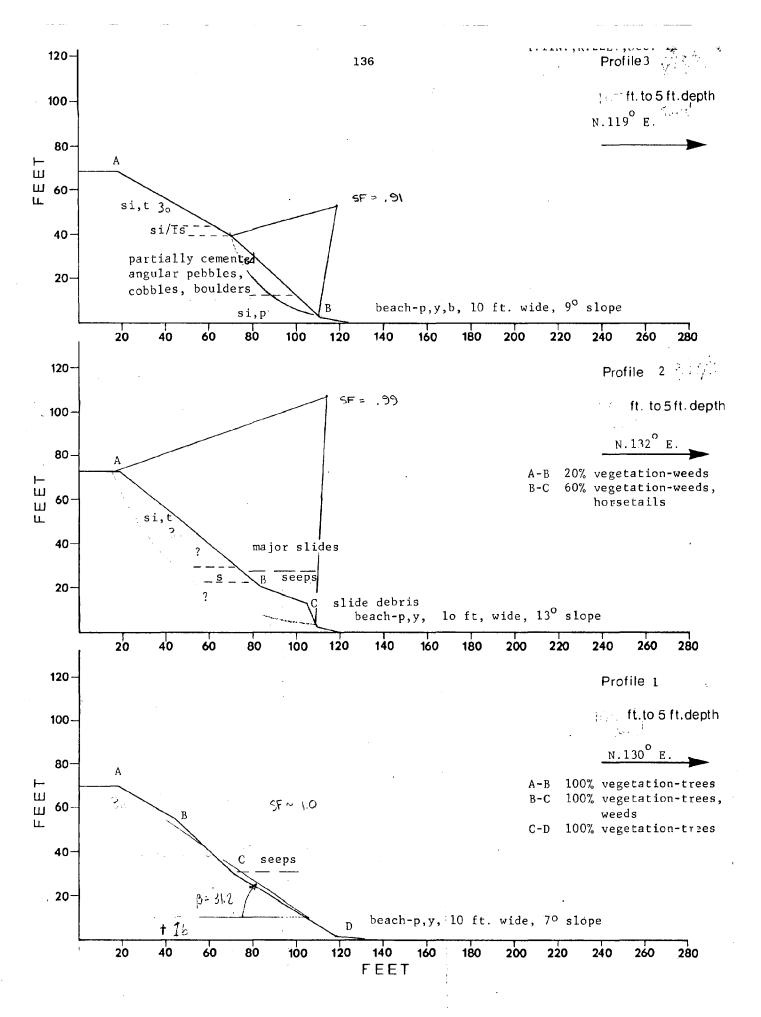
1. BLUFF	a-relatively stable,no recent failures	b-shallow translational slides	c-terrace protects a relatively stable slope no recent failures	d-shallow translational slides
	e-relatively stable, no recent failures, subject to rapid future toe erosion			
2. TOE	<pre>a-in place but unknown, sand most probable e-in place sand</pre>	b-red-brown till slide debris	c-small sand terrace	d-red-brown till slide debris
3. ВЕАСН	a-5to 15 ft. cobbles and pebbles	b-about 20 ft. pebble and cobble	c-5 to 15 ft. cobbles and pebbles	d-20 ft. widening to 30 ft. at end of section, pebbles and cobbles
4. STRUCTURES-none this section

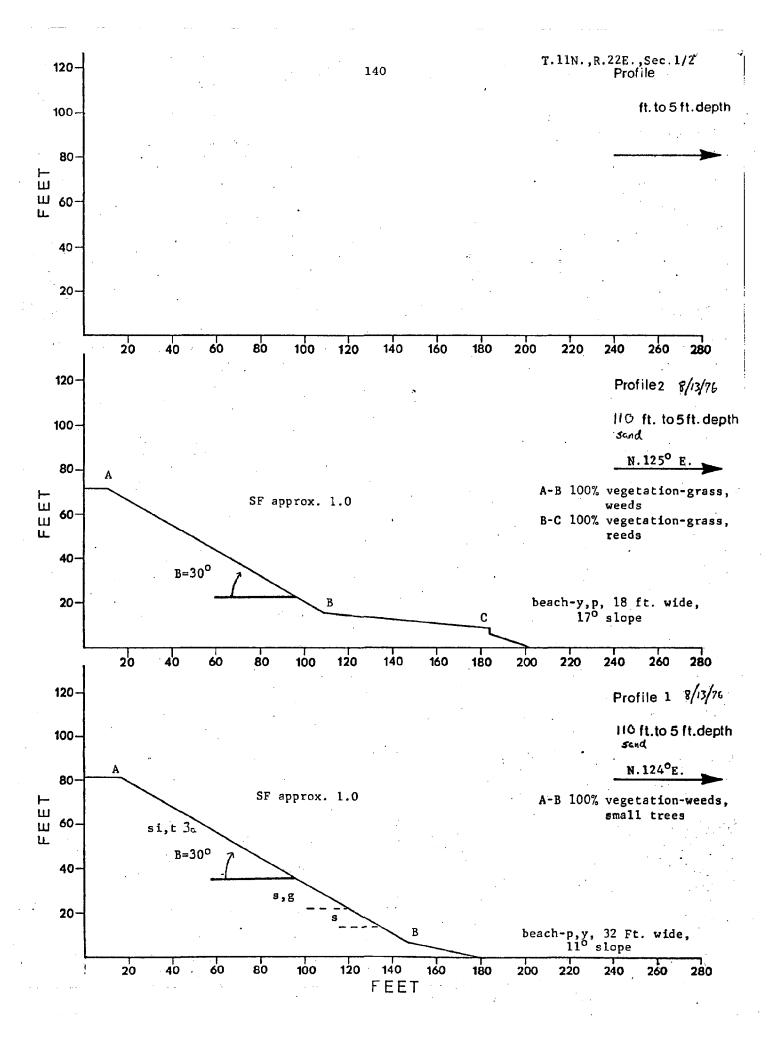
1. BLUFF	a-relatively stable, no recent failures	b- bluff 65 ft. high,constar 30° slope angle, 100% vegetation- small to large trees	1	s, 40 to 50 ft. gradual slope 100% vegetation-
2. TOE	a-red-brown till slide debris	b-medium grained buff sand		
3. BEACH	a-less than 20 ft. cobbles and pebbles	b-5 to 20 ft. cobbles and pebbles	c-5 to 20 ft. very angular cobbles of bedrock	d-5 to 20 ft. clean bedrock shelf
	e-less than 20 ft. sand and pebbles	, I
